ELECTRONIC MONITORING IN THE NEW ZEALAND INSHORE TRAWL FISHERY: A PILOT STUDY

January 2010

Electronic Monitoring In The New Zealand Inshore Trawl Fishery: A Pilot Study

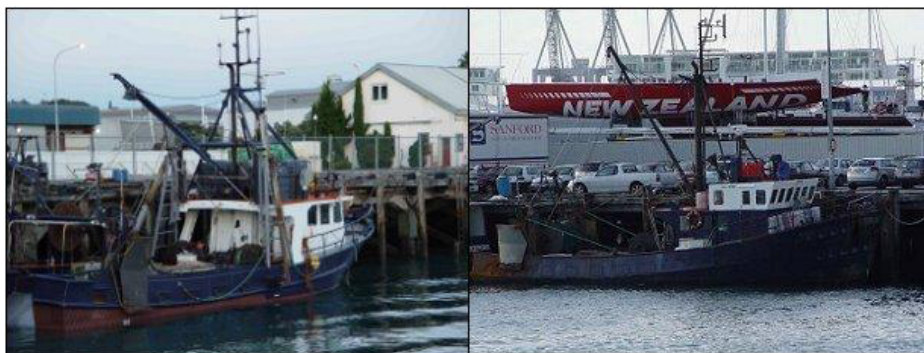
Figure 2. The two inshore trawl vessels that participated in the study shown alongside in Auckland (vessel identifiers have been removed).

Two inshore trawl vessels of similar tonnage were selected by vessel managers at Sanford to participate on this study. The field component began in March 2008 with the first EM system installed on V1 and the second system installed on V2 in early May 2008 and continued through to November 2008 when the systems were removed. Lat 37 staff installed the EM systems on both vessels and serviced the EM equipment roughly every four to six weeks for the duration of the field effort. Each service period varied in length and number of trips depending on accessibility to the vessel. Camera configurations varied across the pilot project as changes to the set-up were made during the scheduled services. Communication and service schedules were organised between vessel managers at Sanford and Lat 37. Each service event included an operational check of the equipment and a cursory analysis of the data collected, adjustments to sensors as needed, and data retrieval. EM systems were aboard vessels for multiple trips and often during initial

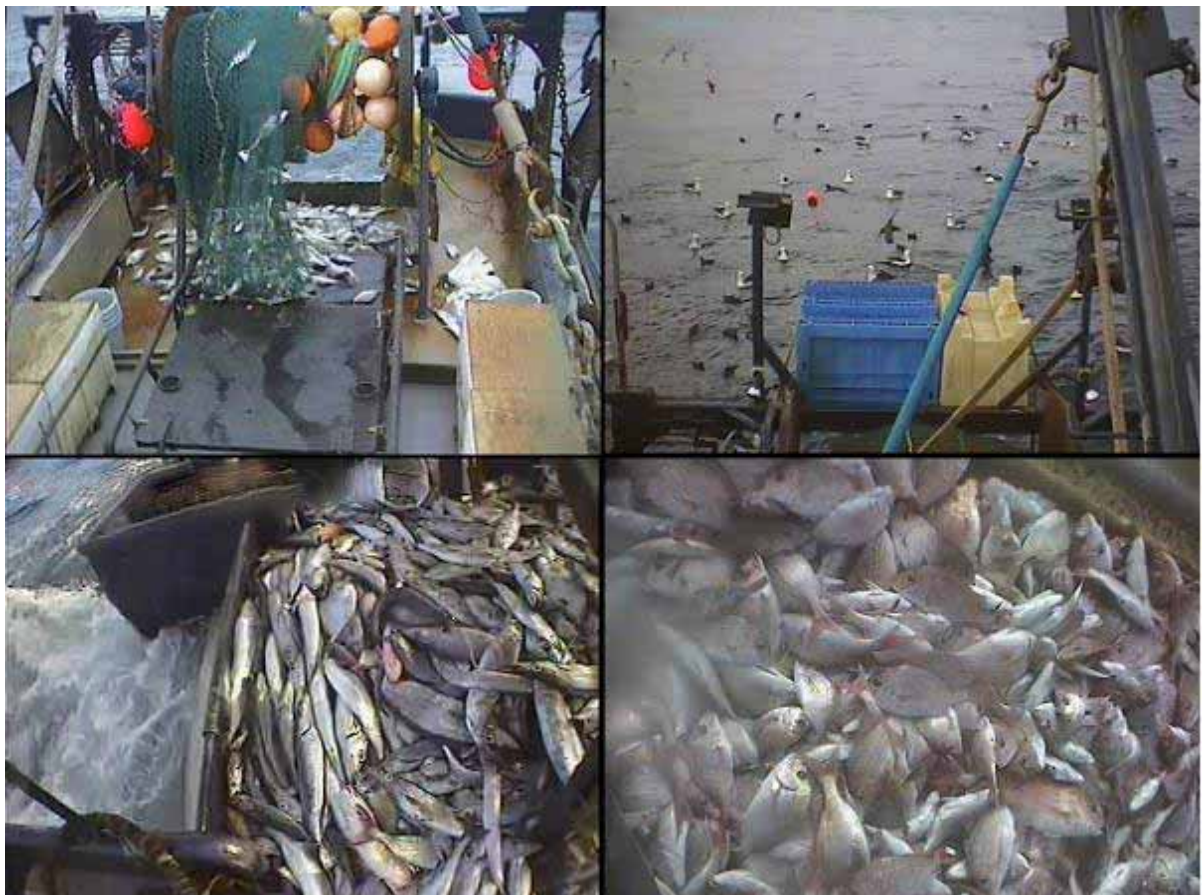
Figure 3. Sample images from V1; the top left camera view gives an overall view of the complete deck area, the top right was used for assessing seabird abundance and for the detection of mitigation devices. The views from the bottom left and right cameras were reviewed for quantifying and identifying PS bycatch and discharge patterns.

During EM review appropriate camera angles (see Figures 3 and 4) were used to assess for protected species abundances around the stern of the vessel. All observed daylight tows were reviewed during EM analysis and abundance estimates were taken during shooting and hauling activity. Seabirds were the main protected species regularly detected during the EM review process, although dolphins were also seen. Imagery was typically viewed around 1-2 times speed to assess for seabird abundances. The EM viewer's estimates were always less than 100m from the vessel, more likely within 25 metres of the vessel. This range limitation likely explains some of the differences seen when comparing with observer data. An overall estimate was recorded of the number of seabirds seen within the field of view for the duration of the hauling and shooting sample period. Separate abundance estimates were made during shooting and hauling periods and a total abundance estimate for the defined time period was made. Exact seabird counts were not possible, and abundance estimates were classified into the following six abundance categories:

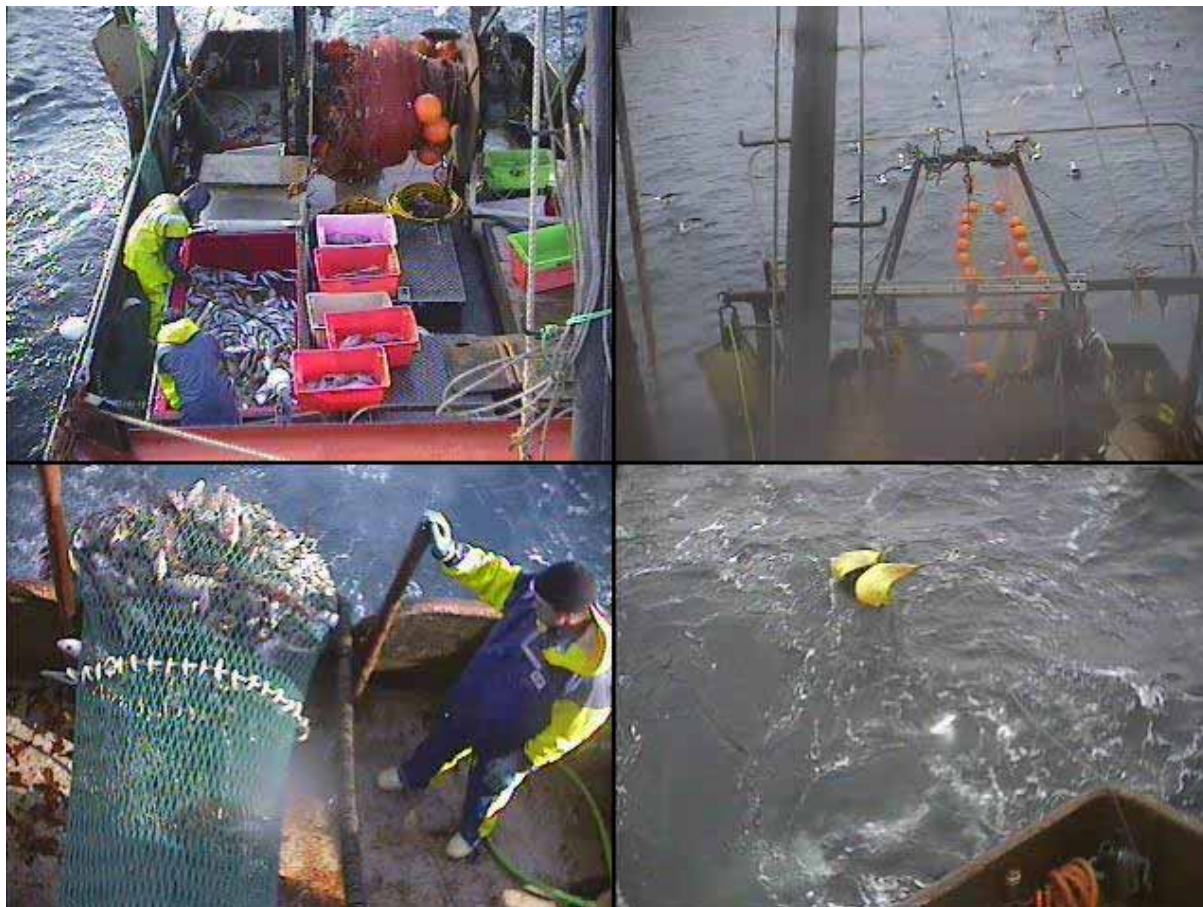
Figure 4. Sample images from V2; the top right shows the camera view used for assessing seabird abundance and mitigation device deployment; the top left camera view was reviewed for analysis of discharge patterns & PS bycatch. The bottom left camera was used to detect PS bycatch when the codend was hauled over the stern, and the camera view on the bottom right was initially setup to view warp strikes but was eventually used to detect deployment of the Warp Scarer that was clipped to the main warp.

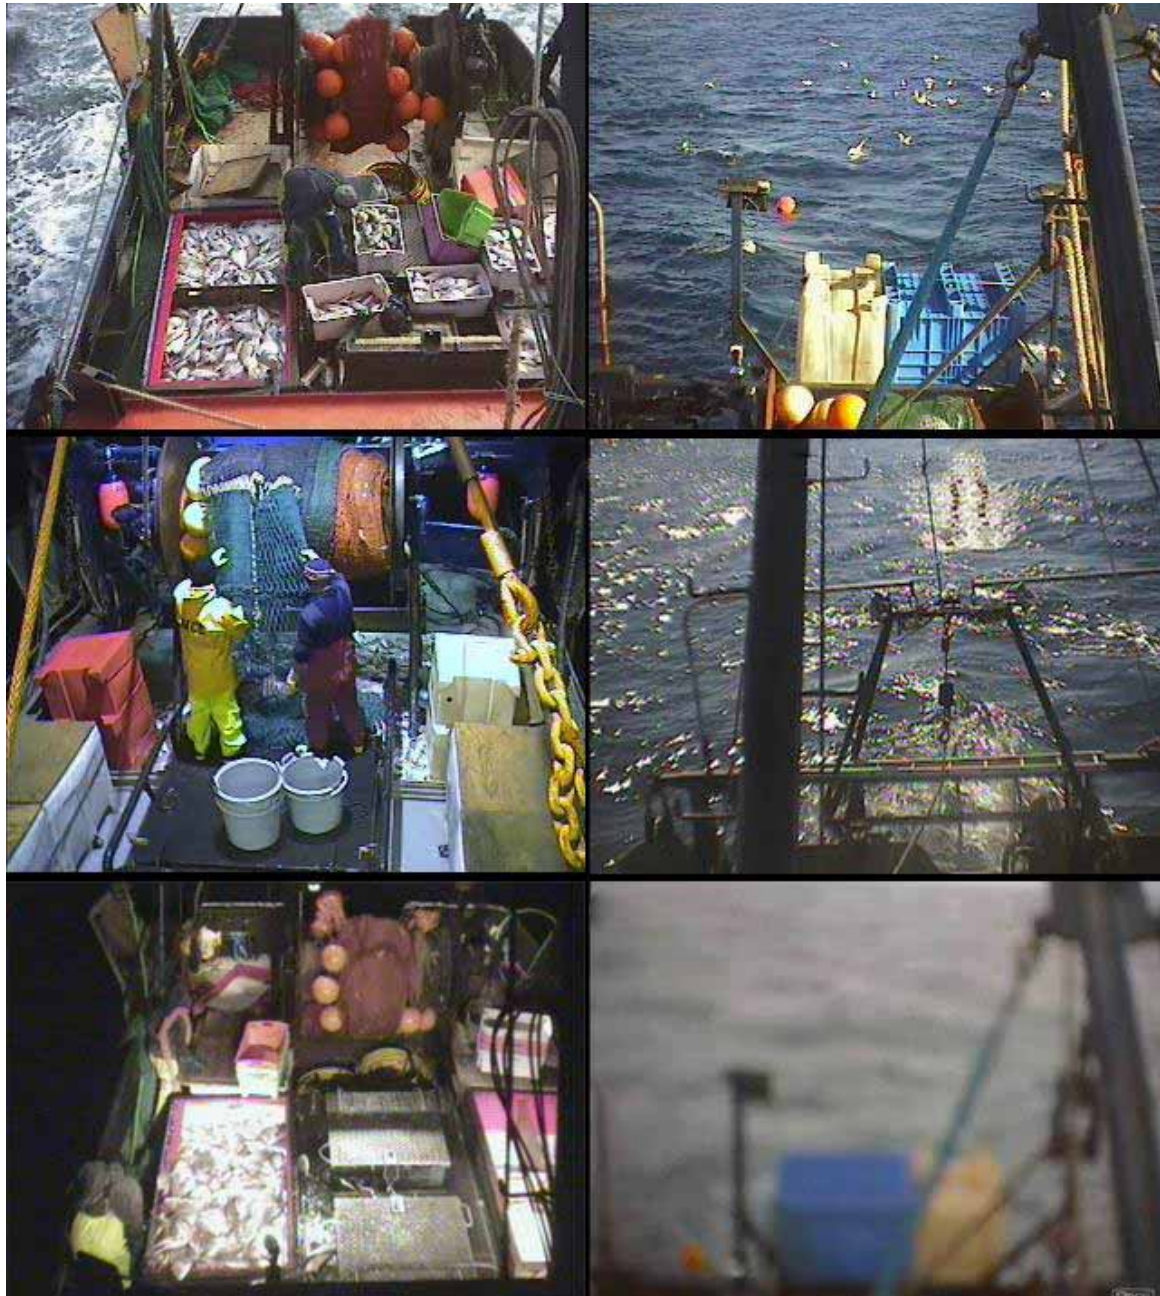
Figure 6. Example imagery to illustrate image quality. On the left from top to bottom: high, medium and unusable imagery for assessing discarded bycatch. On the right from top to bottom: high, medium, and unusable imagery for estimating seabird abundances.

- High. The image data is very clear, the viewer has a good view of catch processing, mitigation device deployment and seabird activity was easy to assess.
- Medium. The view is acceptable, slight blurring or slightly darker conditions, there may be some difficulty assessing discards and mitigation device deployment, but assessment of seabird activity was not greatly hampered.
- Low. The image data is difficult to assess. Some camera views may not be available. Image data is somewhat blurred or lighting has significantly diminished (night time) making discharge, mitigation device deployment or seabird activity difficult to describe.

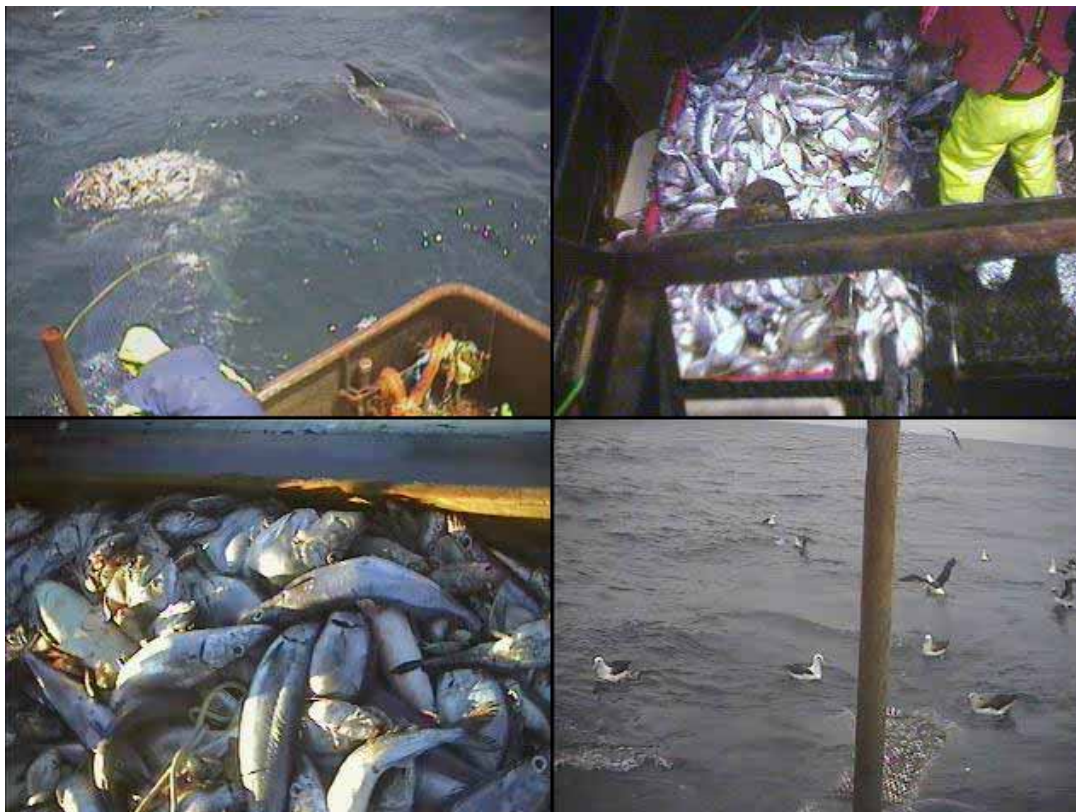
Figure 7. CCTV port stern camera views that were changed: V2 (top, left to right) was changed from showing the stern quarter to capturing the occasional catch processing that sometimes occurred on the port side. V1 (bottom, left to right) was changed from describing the catch on deck to capturing action (seabirds, warp) off the stern quarter.

Changes were made to the camera angles throughout the duration of the project in an effort to better capture all the events of interest. Subsequently, in order to improve the capture of certain events of interest, the changes to the camera configurations diminished the ability to monitor for other objectives. The rotation of camera views in effort to capture all events made subsequent analysis of the image data for this project difficult for the EM viewer.

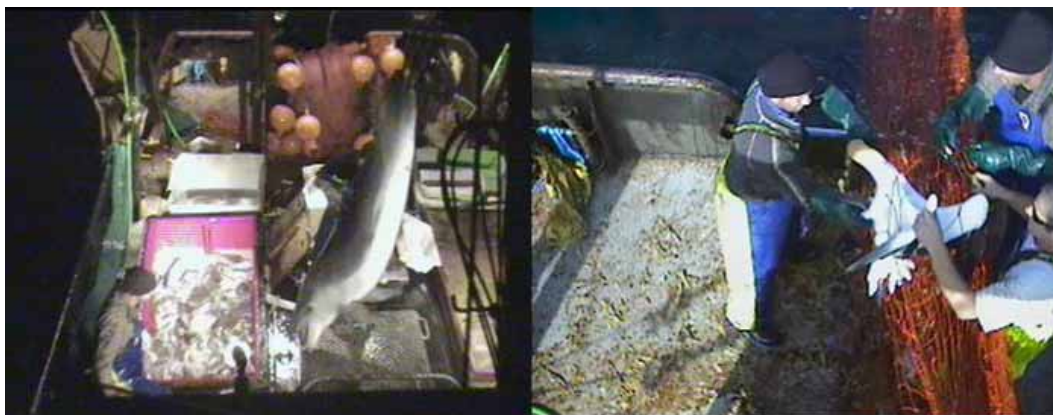
Figure 8. Example images of the protected species interactions recorded during EM analysis. One interaction was seen in the observed data set when a bottlenose dolphin was brought up in the net codend (image on the left). The image on the right shows a Gannet caught in the net that was detected during EM analysis of the non-observed data set.

EM data for the non-observed tows were also reviewed for any incidents of protected species caught in the fishing gear. The results indicate that EM analysis detected the presence of an Australasian gannet (*Morus serrator*) entangled in the belly of the net while the net was being hauled on board V2 (see Figure 8 right). The seabird was identified to the species level and appeared lively in the net when handled by the crew. Another small seabird was also detected landing on the vessel at night, but identification to species level was not possible.

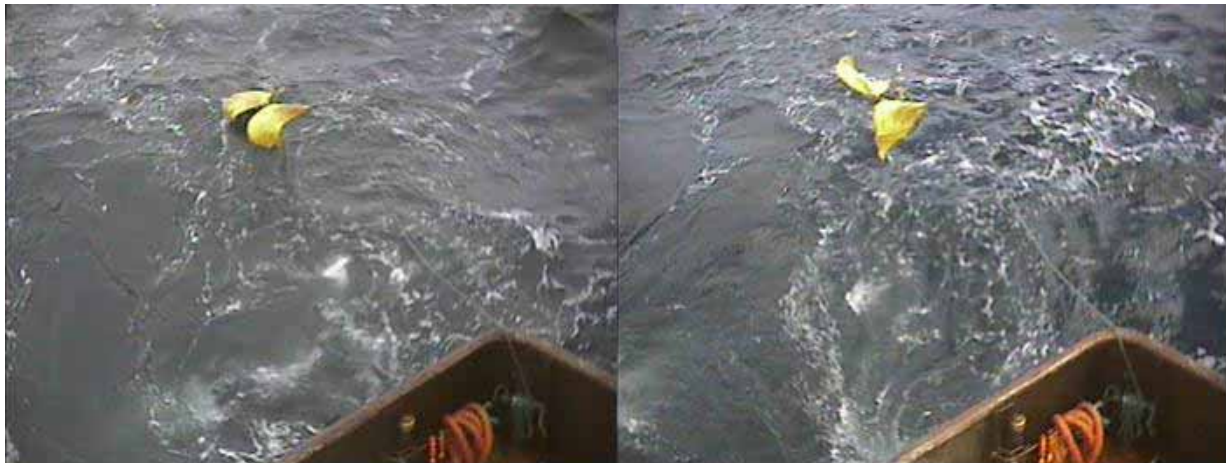
Figure 9. Shows the camera view from V2 that was set-up for assessing seabird interactions with the warp.

The time periods during which the observer was recording for seabird warp strikes could not be properly matched with EM because image data was only recorded up to the 30 minute run on time during shooting and hauling. Throughout the duration of the project appropriate camera views for detecting seabird warp strikes were only available for a limited number of trips. Therefore due to the differences in observer and EM data alignment and the lack of appropriate camera views it was determined that this objective could not be assessed.

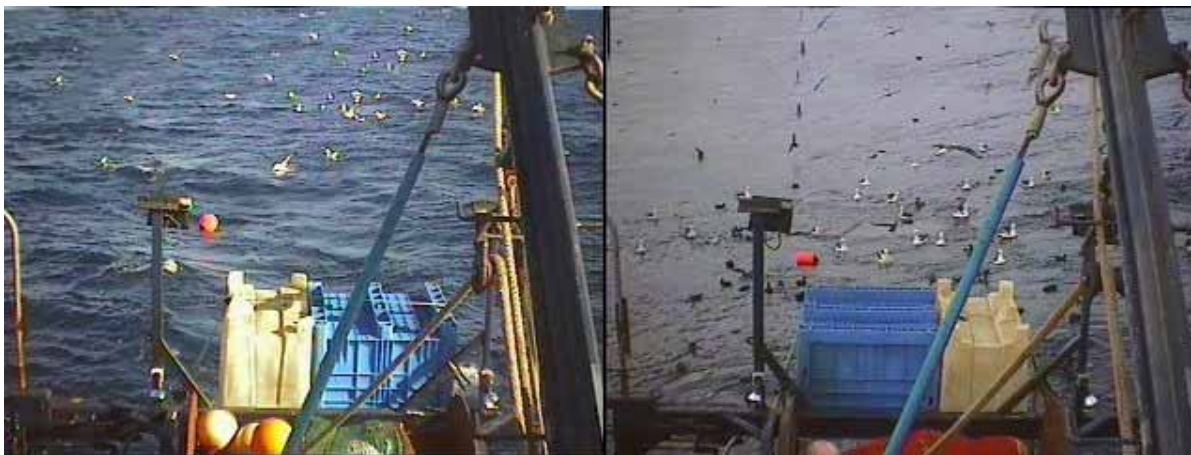
Figure 10. Example images of seabirds around the stern of V1 during hauling operations.

During EM analysis for seabird abundances, the EM viewer identified the seabirds to a general grouping level based on size. The ability of the EM viewer to detect and identify seabirds was a function of both the distance from the vessel and field of camera view. Generally, seabirds could not be identified other than to general category, based on size. It should be noted that the EM viewer had limited experience with identification of New Zealand seabird species. For these reasons and for comparison purposes, EM and observer seabird identification data were grouped into the same categories: seagulls (general); petrels, prions and shearwaters; gannets (general); and albatrosses (general)

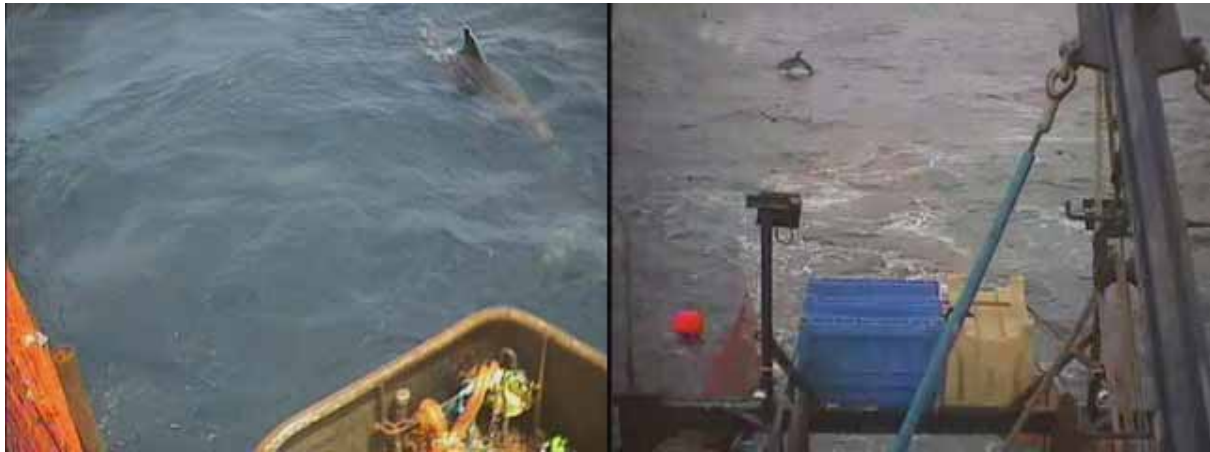
Figure 11. Example images of marine mammal activity from V2, left and V1 right during hauling operations.

During review of the non-observed tows EM was able to detect dolphins around the stern of the vessel, and rough abundance estimates were made (see Figure 11). The EM viewer was able to identify marine mammals to a general species level such as dolphins (*Delphinus spp.*) Additional full resolution images are shown in Appendix III.

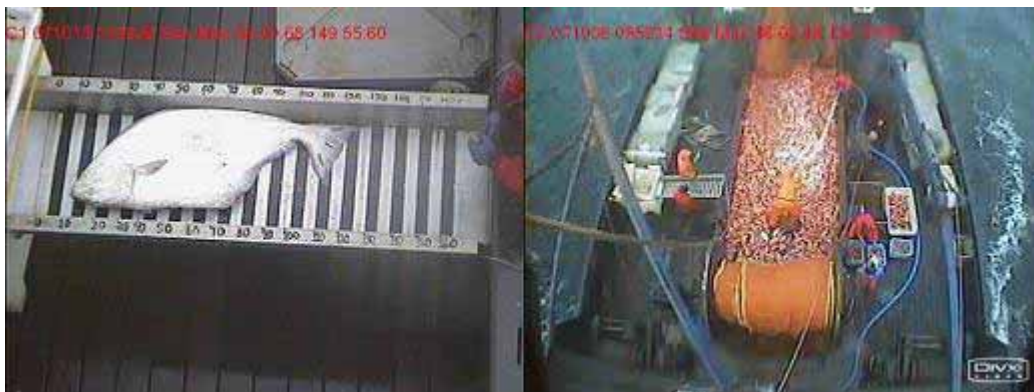
Figure 13. Example of multi camera mosaic view of Alaskan groundfish trawl vessel showing full deck view (right) and a close up view of the discard chute (left). (From McElderry, 2008).

The results of this study misrepresent the potential of EM to quantify and identify discards. Improvements from the opportunistic deployment in this study would be required on several fronts. Camera placements need to both cover the entire area where fish come aboard and also provide a detailed view where specific catch sorting occurs. As well catch sorting procedures by crew would need to ensure that imagery of all non-retained catch could be recorded for census and identification. Essentially, there would be a need to pass non-retained catch across a camera-monitored chute, or similar catch choke point, where individual catch items could be distinguished. The mosaic of deck camera imagery could then be used to confirm catch coming aboard, retained catch being sorted and stowed, and non-retained catch being sorted and returned to the sea. An example of this type of configuration is presented in Figure 13, based on a study in Alaska where discarded fish were identified, counted and measured.

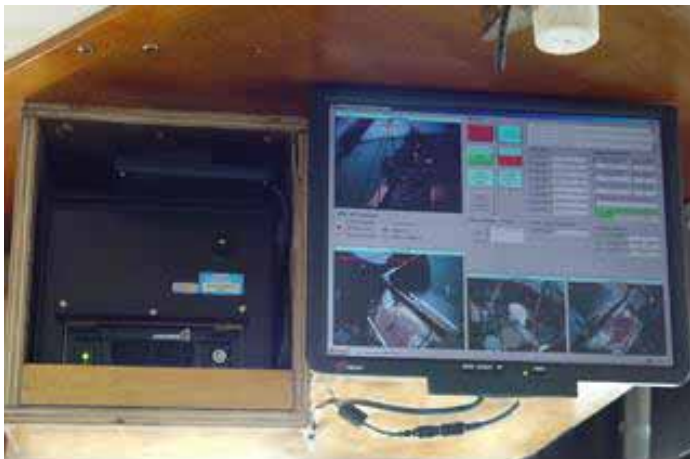
Figure I.I. EM control box and user interface installation on V1 (ceiling mounted).

The heart of the electronic monitoring system is a metal tamper-resistant control box (approx. 38x25x20cm) that houses computer circuitry and data storage devices. The control box receives inputs from several sensors and up to four CCTV cameras. The control box is generally mounted in the vessel cabin and powered from the vessel electrical system. The user interface provides live images of camera views as well as other information such as sensor data and EM system operational status. The interface has been designed to enable vessel personnel to monitor system performance. If the system is not functioning properly, technicians can usually troubleshoot the problem based on information presented in the screen display.

EM systems use high capacity video hard drives for storage of video imagery and sensor data. The locked drive tray is removable for ease in replacement. Depending upon the number of cameras, data recording rates, image compression, etc., data storage can range from a few weeks to several months. For example, using the standard recording rate of 5 frames per second, data storage requirements are 60-100 megabytes per hour, depending upon the image compression method. Using a four-camera set up and 500-gigabyte hard drive, the EM system would provide continuous recording for 52-86 days.

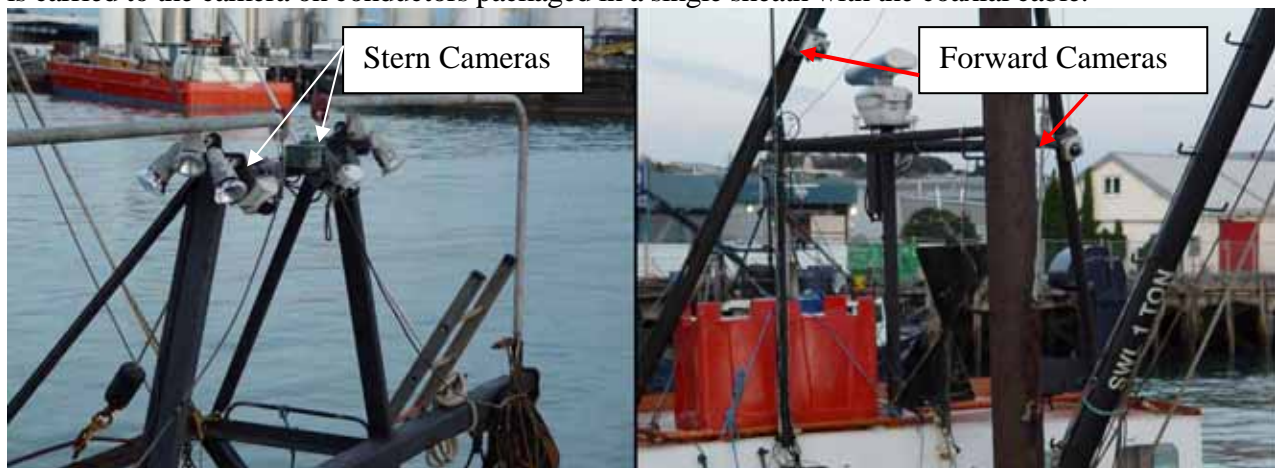
Figure I.II. CCTV camera installations on vessel V2. Each camera has a mounting bracket and stainless steel mounting straps.

Waterproof armoured dome cameras are generally used (Figure A2), as they have been proven reliable in extreme environmental conditions on long-term deployments on fishing vessels. The camera is lightweight, compact and quickly attaches to the vessel's standing structure with a universal stainless steel mount and band straps. In general, three or four cameras are required to cover fish and net handling activity and areas around the vessel. In some cases it is necessary to install a brace or davit structure in order to position cameras in the desired locations.

Colour cameras with 480 TV lines of resolution and low light capability (1.0 lux @ F2.0) are generally used. A choice of lenses is available to achieve the desired field of view and image resolution. The cameras have an electronic iris that adjusts automatically to reduce the effects of glare or low light levels on image quality. The output signal is composite video (NTSC) delivered by coaxial cable to the control box and converted to a digital image (480 x 640 pixel resolution). Electrical power (12 volt DC) is carried to the camera on conductors packaged in a single sheath with the coaxial cable.

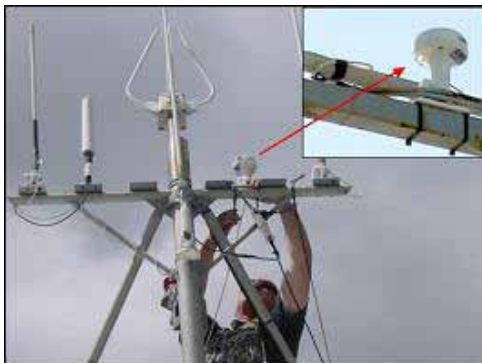
Figure I.III. GPS receiver installed in the rigging of a vessel and a close up photograph of the mounted GPS.

Each EM system carries an independent GPS, integrated receiver and antenna, which is wired directly to the control box. The GPS receiver is fixed to a mount on top of the wheelhouse away from other vessel electronics (Figure A4). The GPS receiver is a 12 channel parallel receiver, meaning it can track up to 12 GPS satellites at once while using 4 satellites that have the best spatial geometry to calculate the highest quality positional fix. The factory stated error for this GPS is less than 15 metres (Root Mean Square). This means that if the receiver is placed on a point with precisely known coordinates, a geodetic survey monument for example, 95% of its positional fixes will fall inside a circle of 15 metres radius centered on that point. The GPS time code delivered with the positional data is accurate to within 2 seconds of the Universal Time Code (UTC = GMT). The EM control box software uses the GPS time to chronologically stamp data records and to update and correct the real time clock on the data-logging computer.

When 12 volts DC is applied the GPS delivers a digital data stream to the control box that provides an accurate time base as well as vessel position, speed, heading and positional error. Speed is recorded in nautical miles per hour (knots) to one decimal place and heading to the nearest degree.

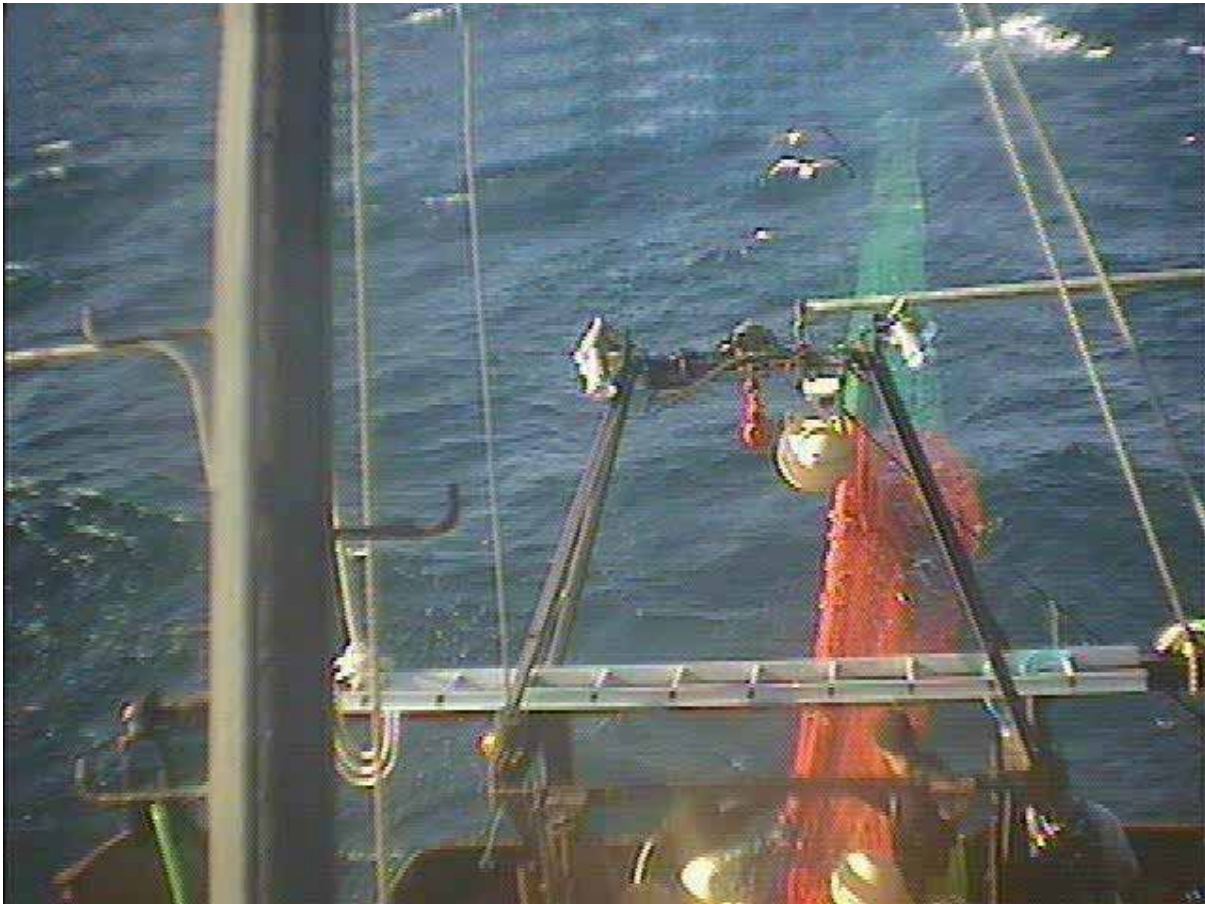
Figure III.I. Sample image from V2 during hauling of fishing gear, seabird abundance category 1 (0-10 seabirds).

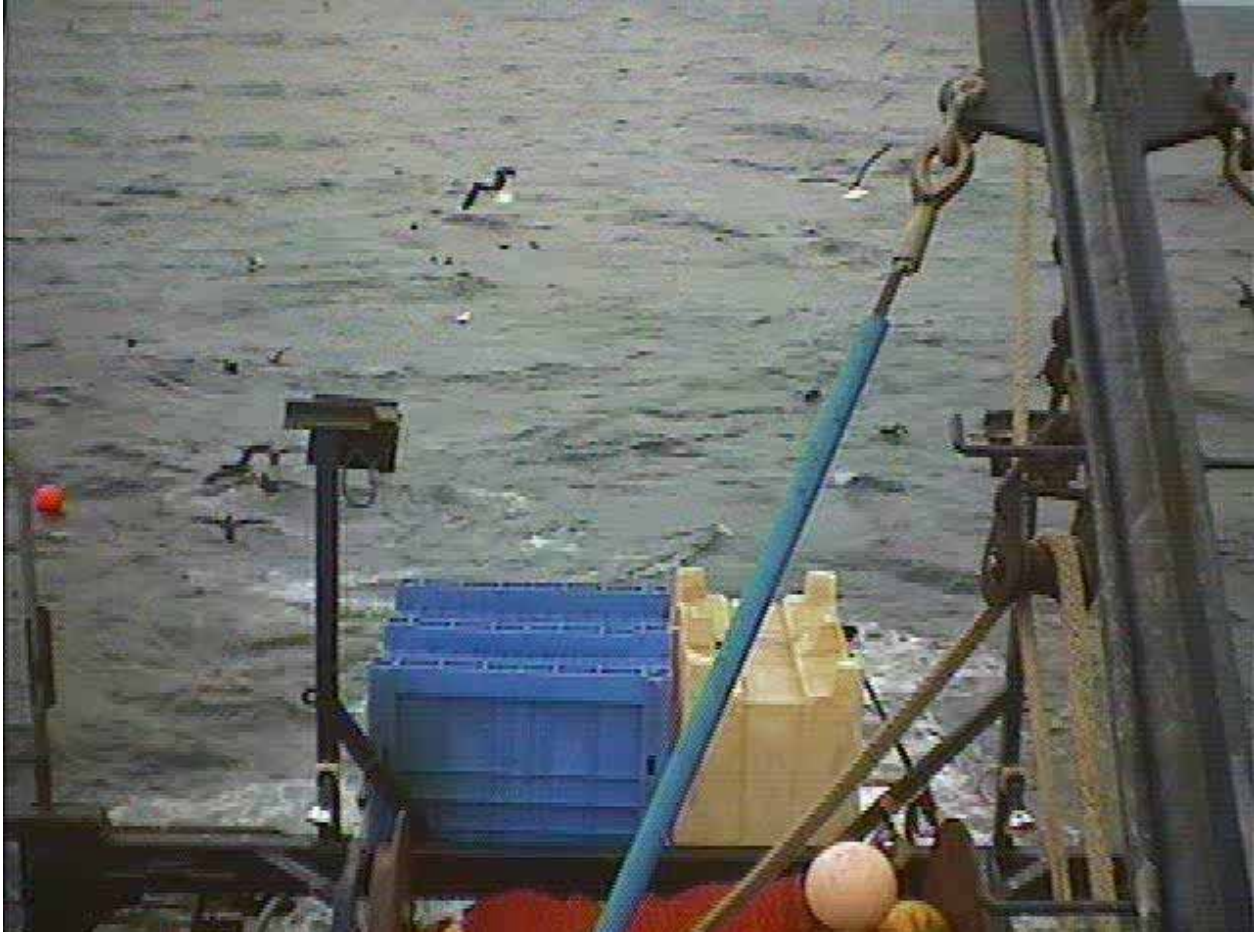
Figure III.II. Sample image from V1 during hauling of fishing gear for seabird abundance category 2 (11-15 seabirds).

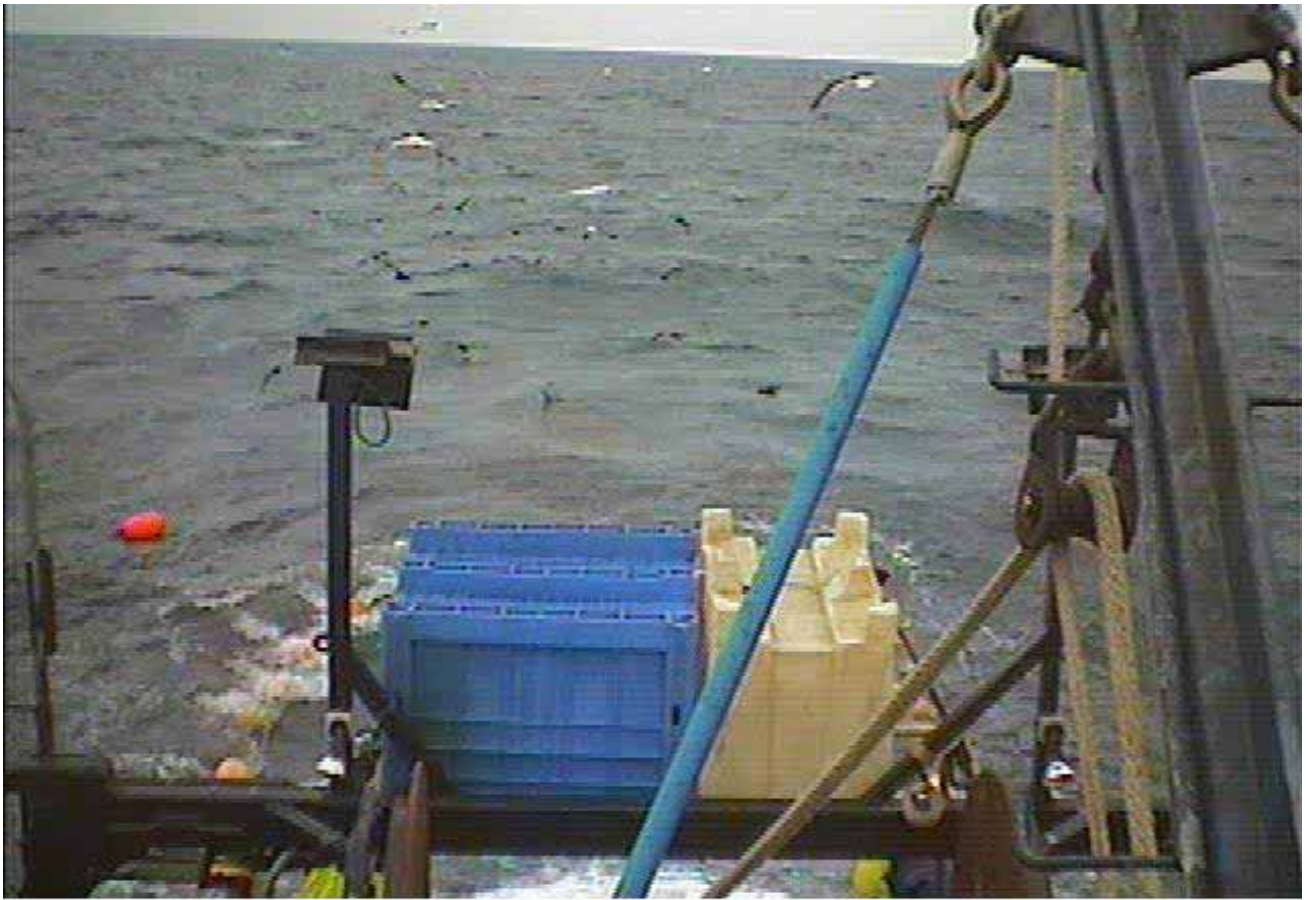
Figure III.III. Sample image from V1 during hauling of fishing gear, for seabird abundance category 3 (16-25 seabirds).

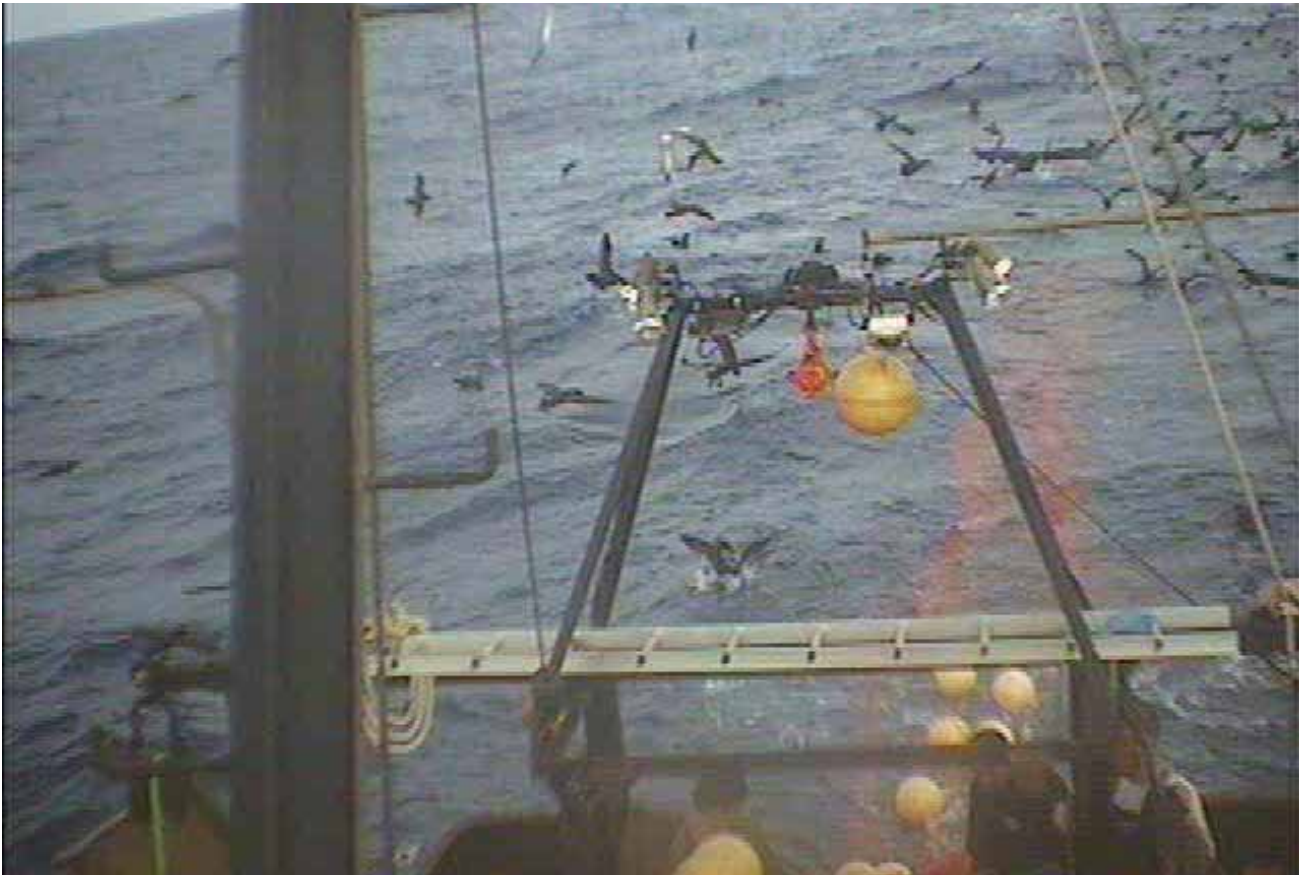
Figure III.IV. Sample image from V2 during hauling of fishing gear, for seabird abundance category 4 (26-50 seabirds).
